Home Inspection Report

123 Main Street
Homeville, PA 17456

New Leaf Home Inspection

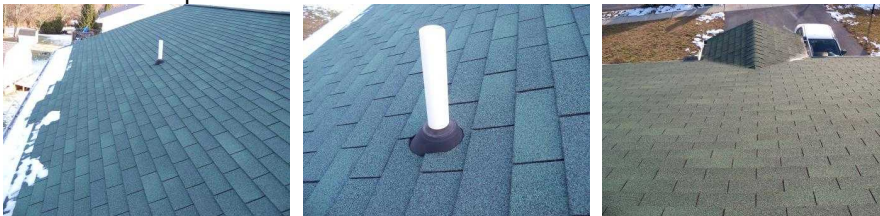
1. Method of Inspection: On roof

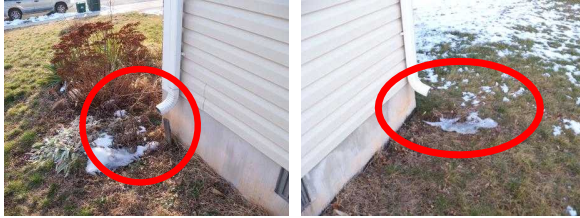
3. Type: Gable
4. Approximate Age: 1-5 Years
5. Acceptable Flashing: Aluminum
6. Acceptable Plumbing Vents: PVC
7. Acceptable Gutters: Aluminum
8. Acceptable Downspouts: Aluminum -- Downspout should be extended to ground and leaders/extensions used to divert water runoff away from the foundation.

9. Not Present Leader/Extension: Missing -- Extend runoff drains to move water away from foundation

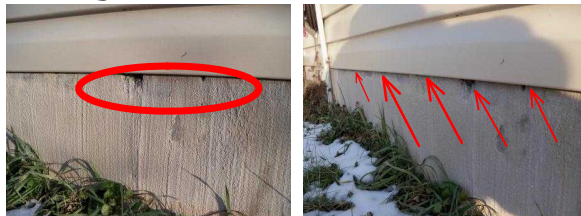
2. Acceptable Foundation: Block -- Recommend sealing gaps adjacent to the vinyl siding.

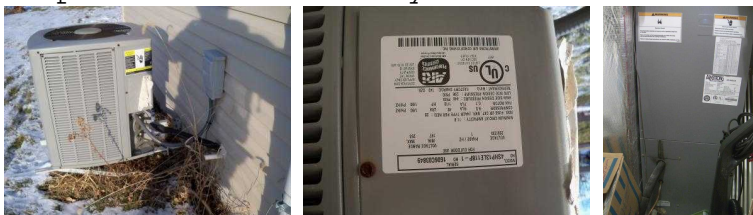
- 1. Not Inspected A/C System Operation: Not inspected -- Due to the season, the heat pump was tested in heating mode only. The cooling mode uses the same components in reverse cycle.

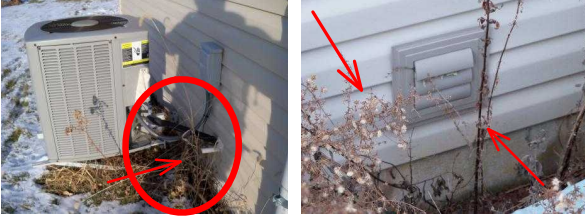
1. Vegetation: Shrubs/Weeds -- Shrubs/Weeds should be trimmed back from areas around dryer vent and heat pump.

6. Marginal Vegetation: Shrubs/Weeds -- Shrubs/Weeds should be trimmed back from areas around dryer vent and heat pump.
